BUILDING AND SITE LIGHTING ASSESSMENTS

ALASKA REGIONAL HOSPITAL – CASE STUDY

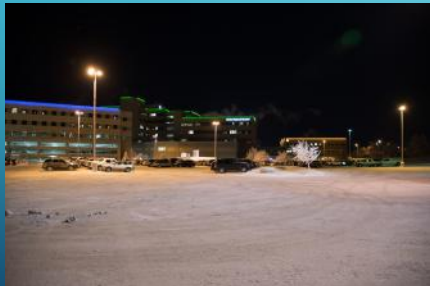
GROUND VIEW

HID LIGHTING

- Unmaintained HID lighting.
- Existing lighting consisted of (89) 1000w fixtures and (43) 250w fixtures
- Existing line voltage photocell

- Existing fixture wattage for the complete site was 111kW.
- Accepted lighting retrofit solution consisted of 23kW.
- Based on their annual usage this retrofit is saving them \$30,000.00 per year on energy.
- Not only did this improvement save the hospital money, but it increased the safety in the lot.

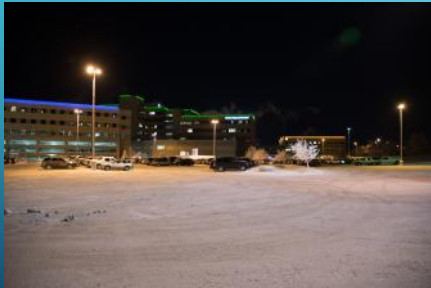
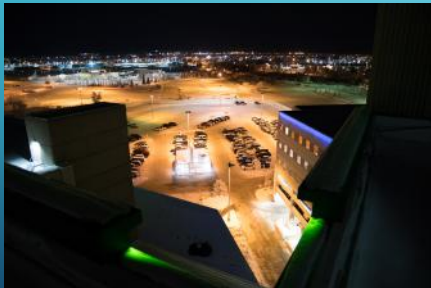
HID LIGHTING

BEFORE AND AFTER
